INDOOR AIR QUALITY ASSESSMENT

**Taft Elementary School
16 Granite St
Uxbridge, MA 01569**

Prepared by:
Massachusetts Department of Public Health
Center for Environmental Health
Emergency Response/Indoor Air Quality Program
September 2005

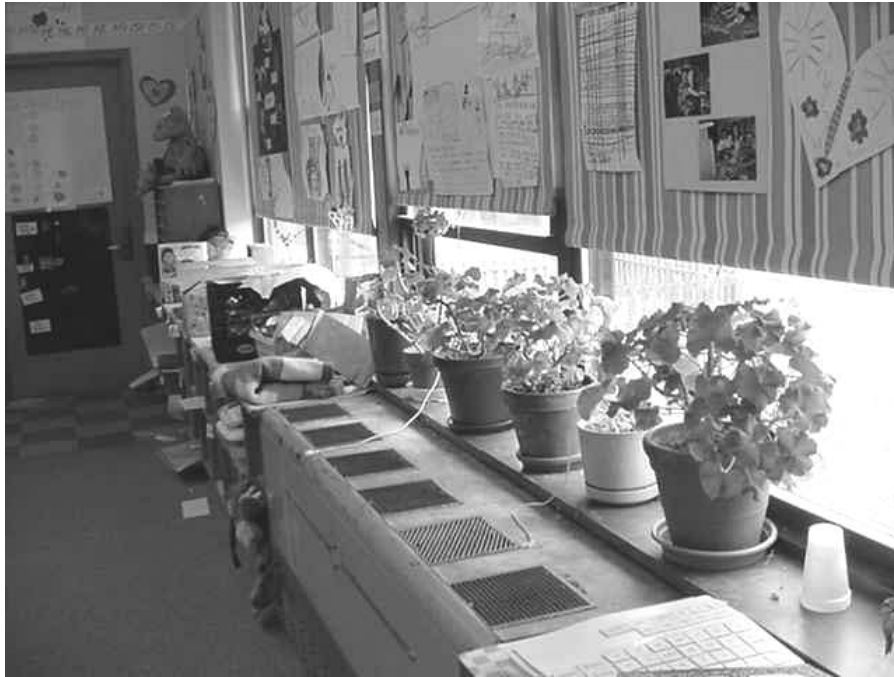
Picture 1

Fresh air in both the 1952 and 1998 classrooms is supplied by unit ventilator (univent) systems (Pictures 1 and 2). A univent draws air from the outdoors through a fresh air intake located on the exterior wall of the building (Picture 3) and returns air through an air intake located at the base of each unit ([Figure 1](#)). Fresh and return air are mixed, filtered, heated and provided to classrooms through an air diffuser located in the top of the unit. The majority of univents were not operating during the assessment. Obstructions to airflow, such as papers and books stored on univents and items placed in front of univent returns, were seen in a number of classrooms (Pictures 1 and 2). In one instance, clay figurines were placed near a univent diffuser so that air passing over the figurines would act to dry the clay (Picture 4). Placing these items

Plants were noted in several classrooms, some on top of univents (Picture 1). Some plants were placed on carpeting (Picture 18). Plants should be properly maintained and equipped with drip pans. Plants should be located away from ventilation sources (e.g., univents) to prevent aerosolization of dirt, pollen or mold. Plants should not be placed on porous materials such as carpets, because water damage to porous materials may lead to microbial growth.

Classroom univent in 1952 wing, note plants

1. Examine each univent for function. Operate univents while classrooms are occupied.
Check fresh air intakes for repair and increase the percentage of fresh air intake if necessary.
2. Examine exhaust vents for function and make repairs as necessary.

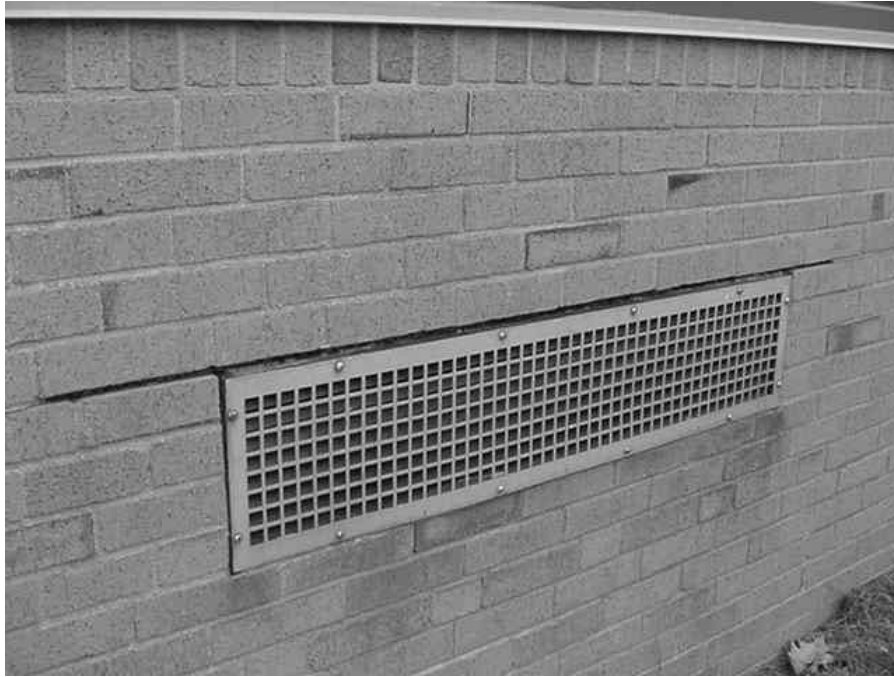
Picture 3

A number of breaches were seen around the building exterior. Missing mortar was observed in a number of areas (Picture 3). A number of utility holes were also observed (Picture 22). Holes, breaches, and seams are points through which water can penetrate the building,

Univent fresh air intake

15. Consider repointing building exterior. Seal breaches to the building exterior to prevent pest and water intrusion.
16. Replace missing soffit vents after cleaning interior area of any debris or bird-related materials/wastes.

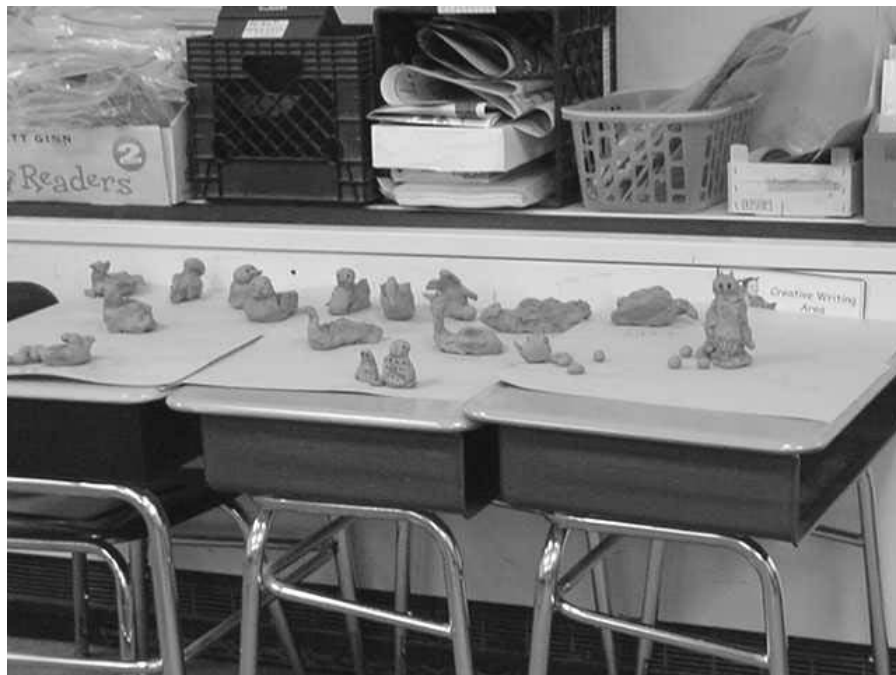
Picture 4

near the supply diffuser can serve to distribute dried clay particles. In order for univents to provide fresh air as designed, these units must remain activated and allowed to operate while rooms are occupied. Univent intakes and diffusers must also remain free of obstructions.

Items placed on and in front of univent, note clay figurines

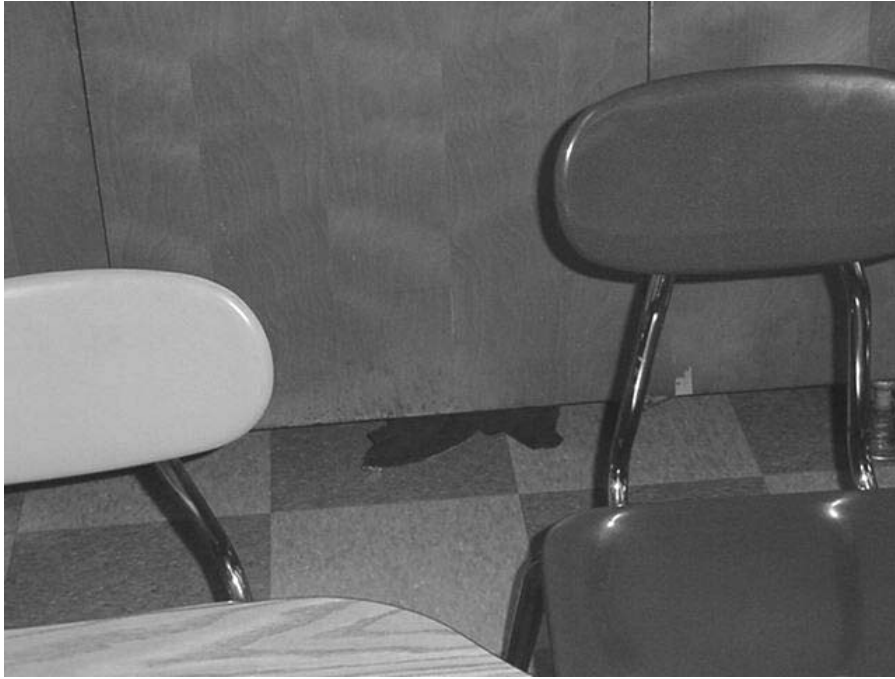
Picture 5

Undercut closet door

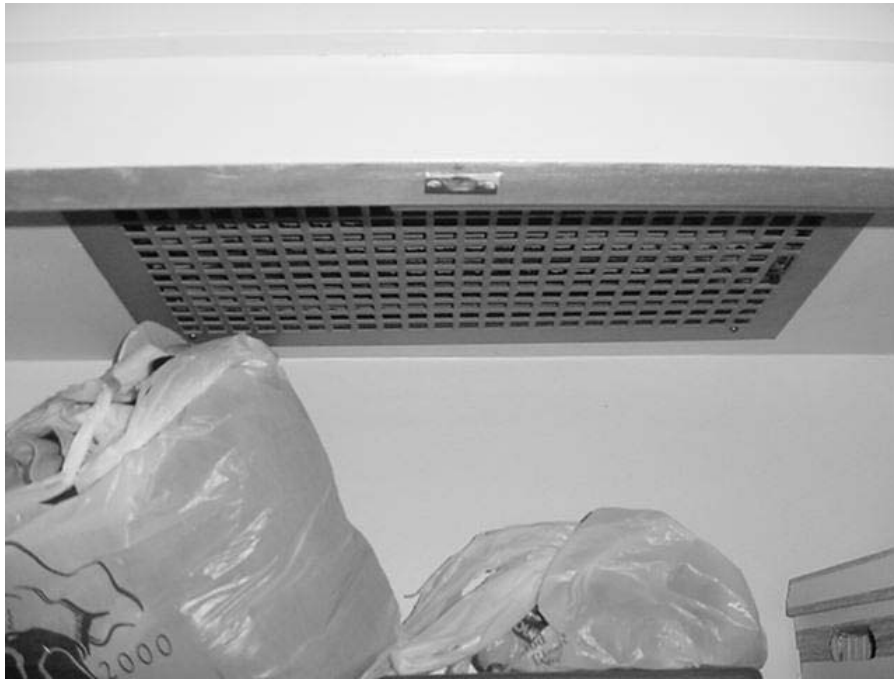
Picture 6

Closet exhaust vent, notice items on shelf below vent

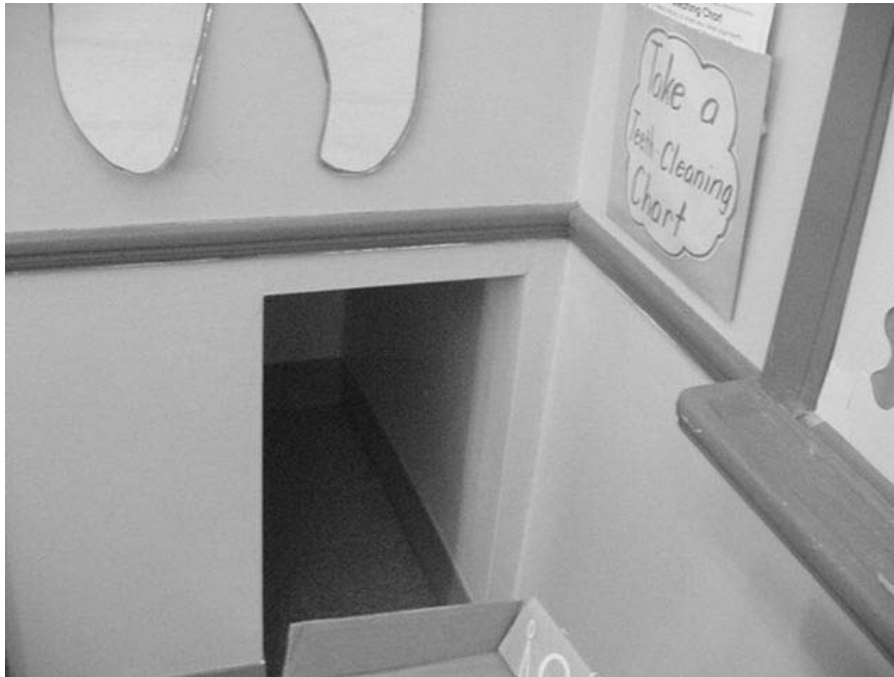
Picture 7

Cubby-style exhaust

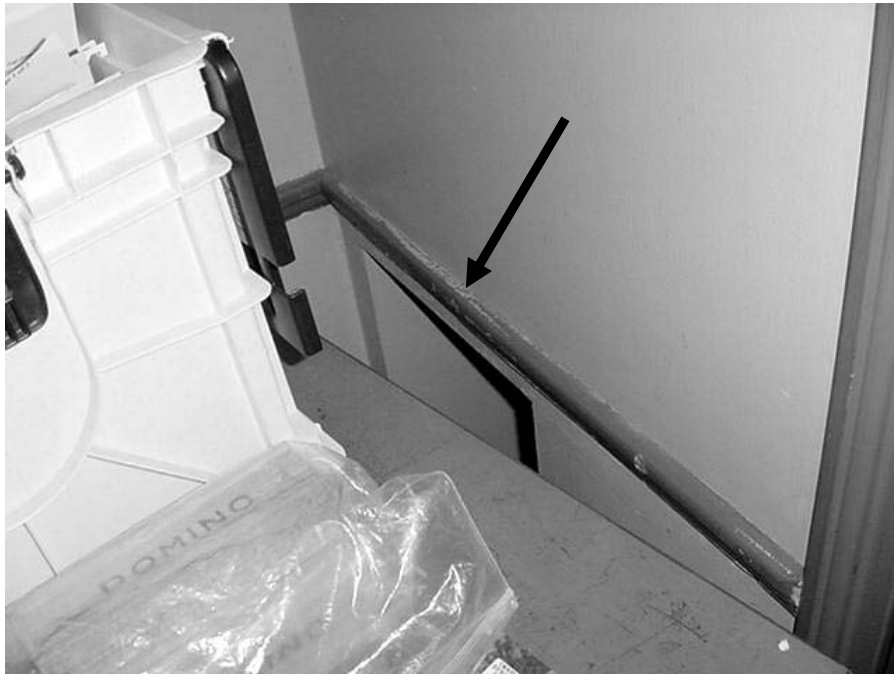
Picture 8

Blockage to cubby-style exhaust

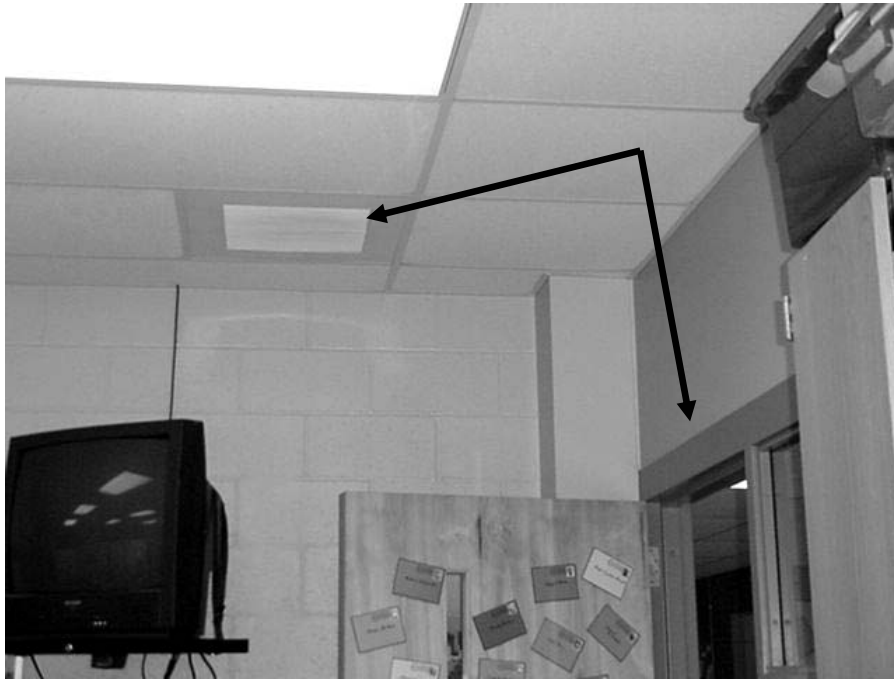
Picture 9

Ceiling exhaust vent near hallway door

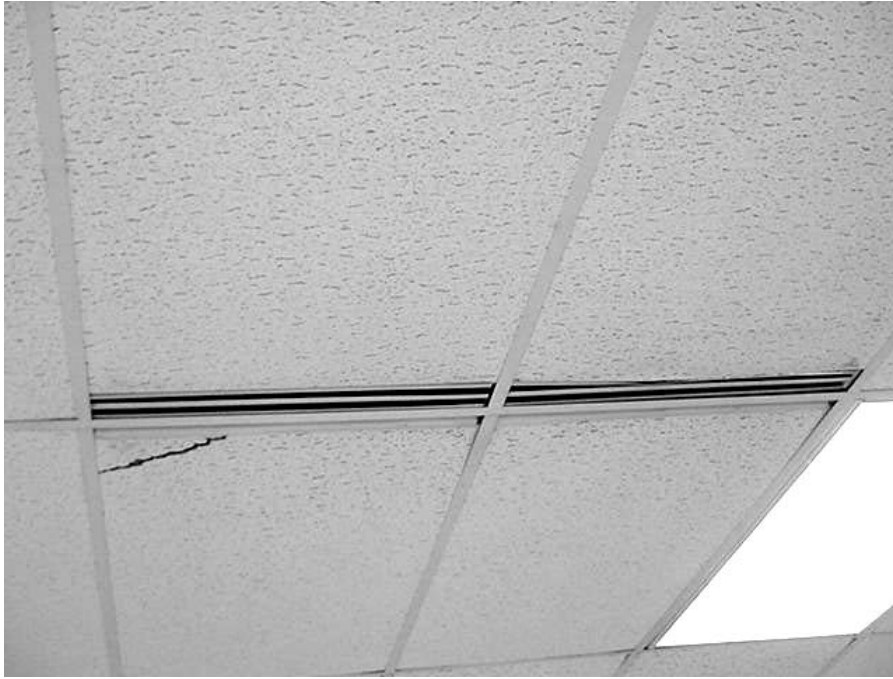
Picture 10

Ceiling-mounted slotted air diffuser

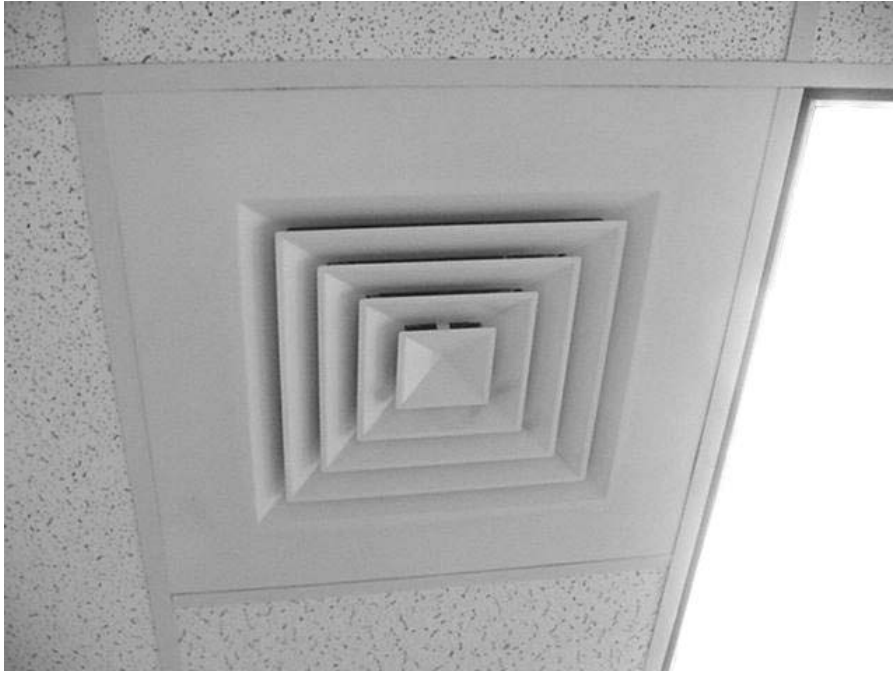
Picture 11

Ceiling-mounted directional air diffuser

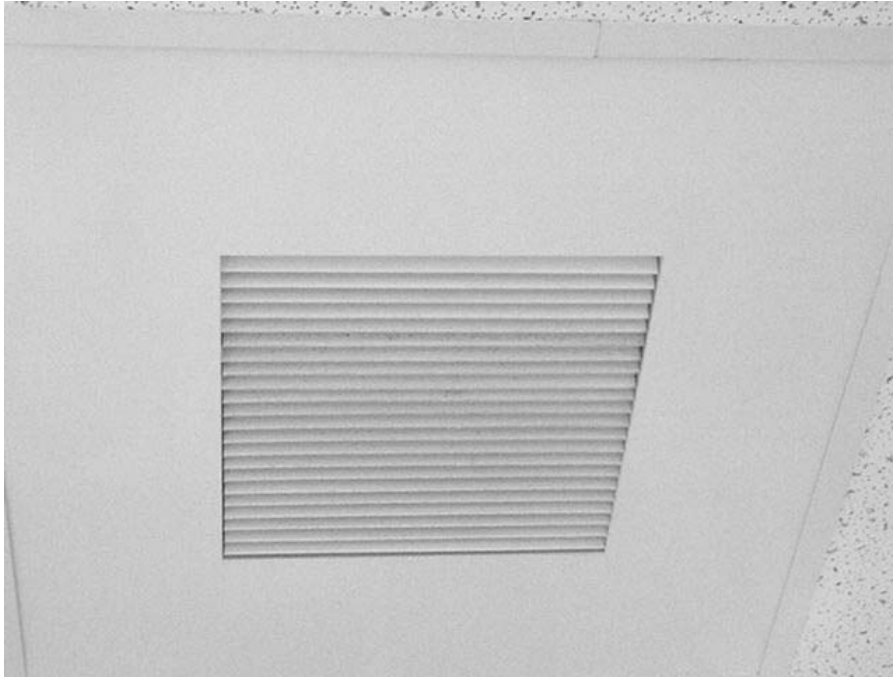
Picture 12

Ceiling-mounted return vent

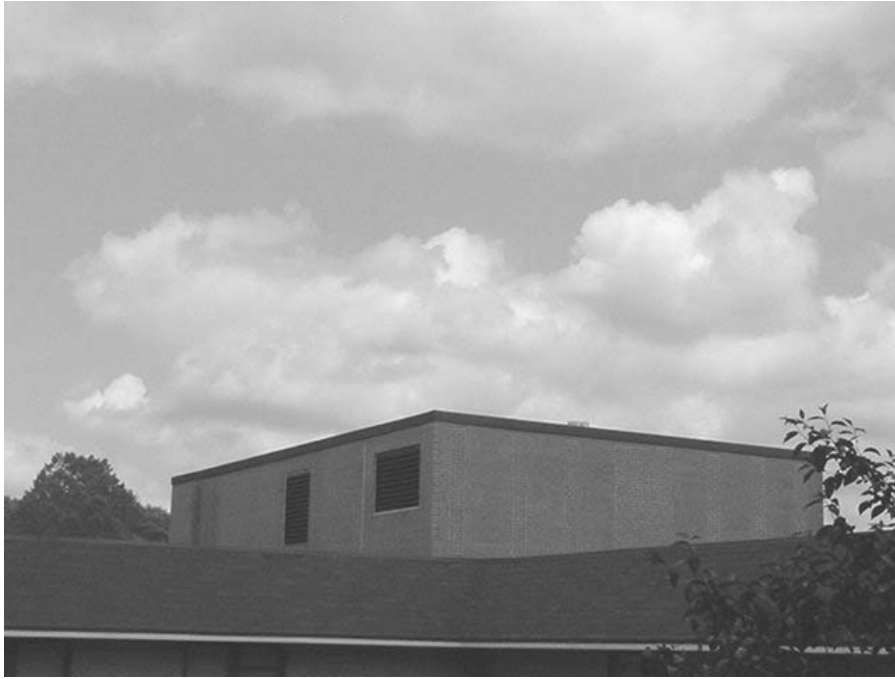
Picture 13

Rooftop AHU penthouse

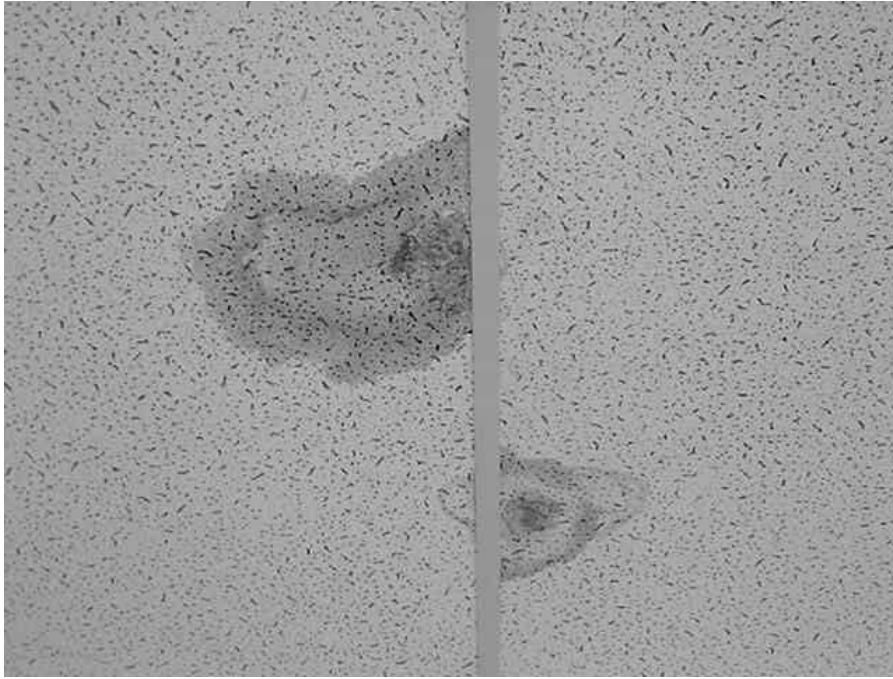
Picture 14

A number of areas throughout the school had water-stained ceiling tiles (Picture 14). Some ceiling tiles in the hallway appeared to be recently damaged and visibly wet (Picture 15). TES staff indicated leaks are primarily related to roof damage. The majority of water-damaged ceiling tiles were observed in the 1989 portion of the building, the of which is original to the building. Plans to replace the 1989 portion of the roof are on a capital projects list. The roofs for both the 1952 and 1998 wings date to 1998. Water-damaged ceiling tiles can provide a source of mold growth and should be replaced after a water leak is discovered and repaired. Appropriate measures should also be taken to minimize the aerosolization of particulates from tile removal/replacement.

Water-damaged ceiling tiles

9. Continue with plans to replace roof the roof of the 1989 portion of the building. Replace water-damaged ceiling tiles. These ceiling tiles can be a source of microbial growth. Examine the non-porous surface beneath the removed ceiling tiles and disinfect with an appropriate antimicrobial. Appropriate measures should also be taken to minimize the aerosolization of particulates from tile removal/replacement.

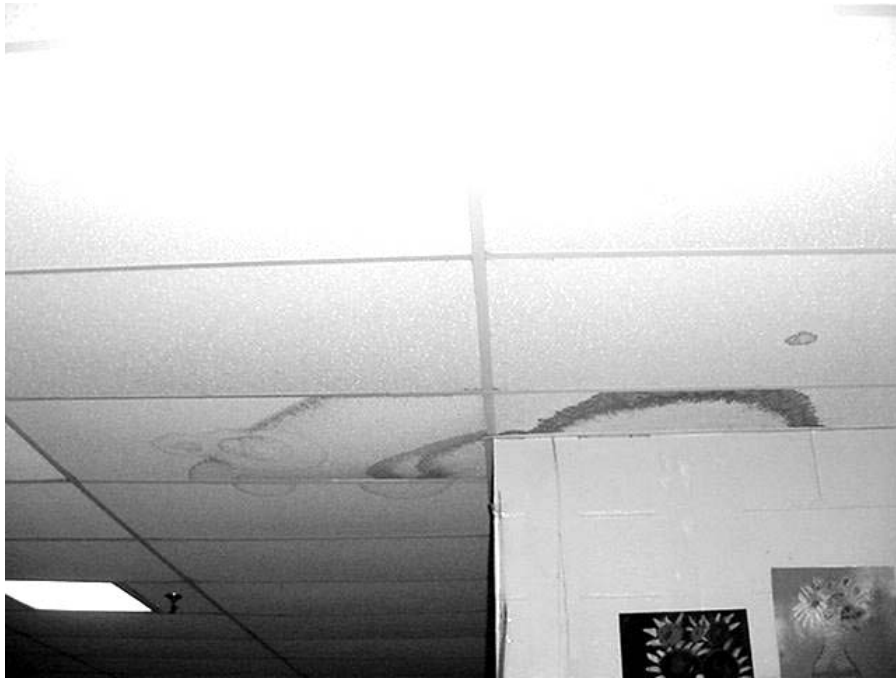
Picture 15

Moist ceiling tiles

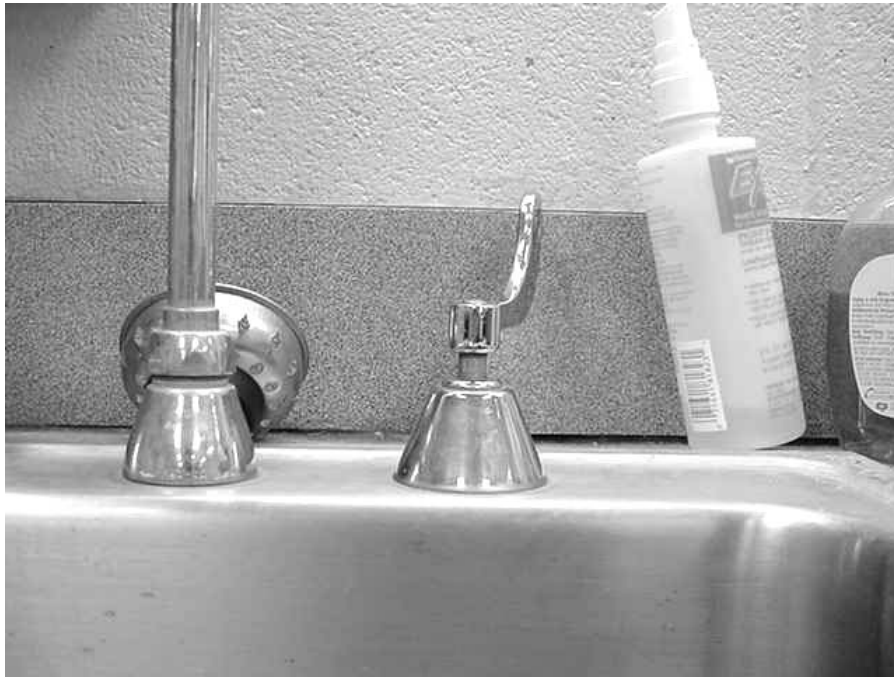
Picture 16

Other sources for potential water damage were observed. Open seams between the sink countertop and backsplash were observed in several rooms (Picture 16). If not watertight, water can penetrate the seam, causing water damage. In addition, the interior of a cabinet beneath a sink was noted to be water damaged (Picture 17). Water penetration and chronic exposure of porous and wood-based materials can cause these materials to swell, show signs of water damage and lead to potential mold growth.

Breach between sink countertop and backsplash

10. Seal breaches, seams, and spaces between sink countertop and backsplash to prevent water damage.
11. Examine sink pipes for leakage. Ensure clapboard sink cabinet is dried appropriately; make repairs/replace as necessary.

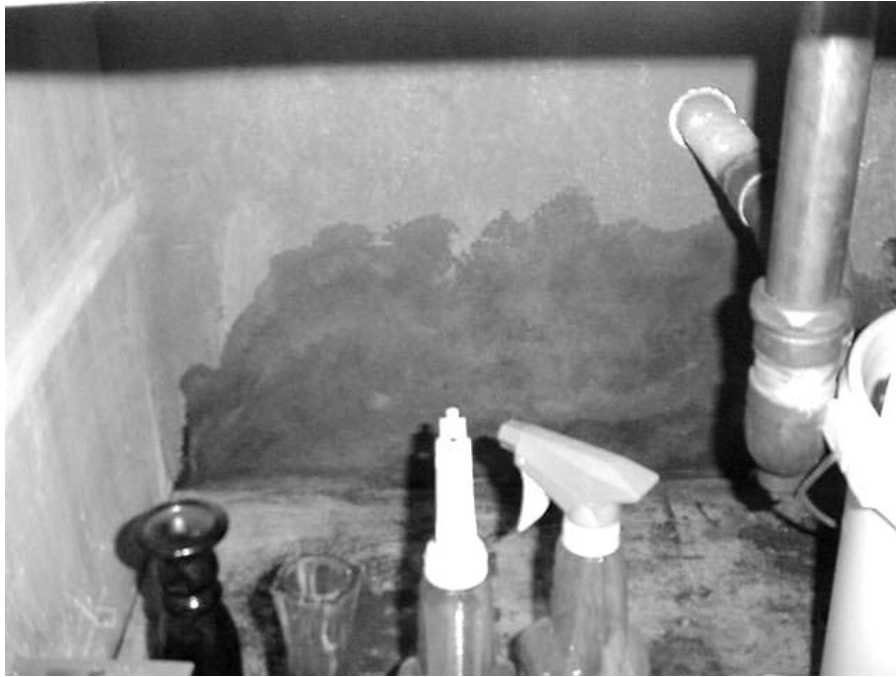
Picture 17

Moistened sink cabinet

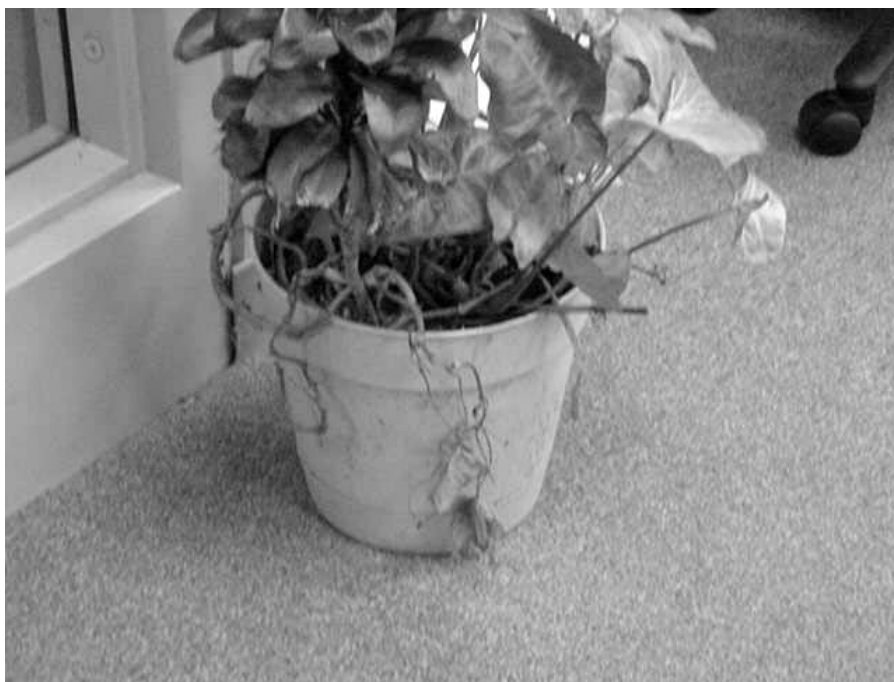
Picture 18

Plant on carpet

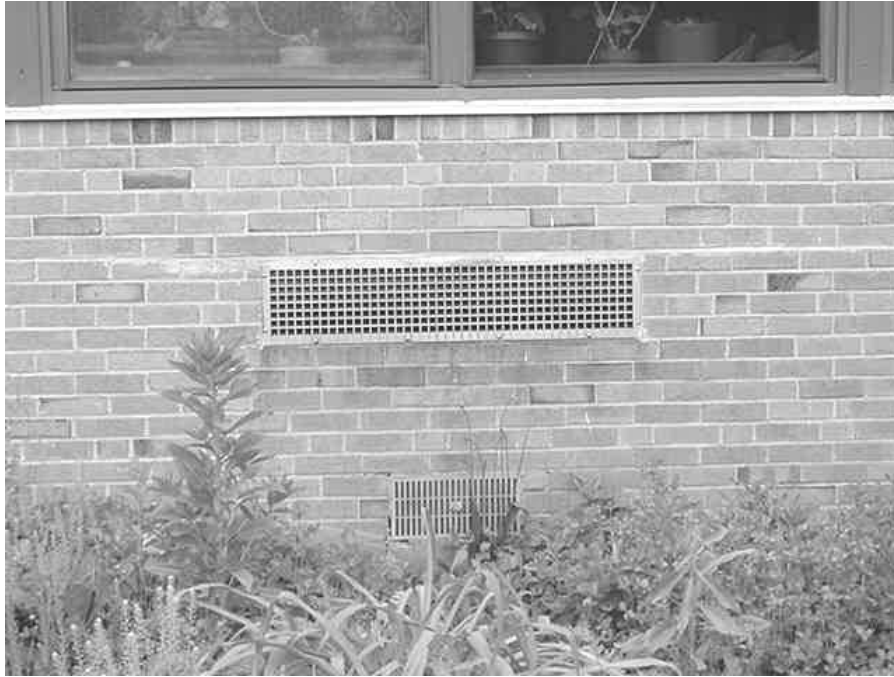
Picture 19

A passive crawlspace vent was observed near a univent fresh air intake (Picture 19). Plants and other materials were also located outside the building near univent fresh air intakes (Pictures 20 and 21). Odors and materials from the crawlspace, plants and materials in close proximity to univent fresh air intakes may be entrained and subsequently distributed into the classroom. Consideration should be given to directing crawlspace exhaust away from fresh air intakes. Plants and other materials should be removed and placed away from univent fresh air intakes.

Crawlspace vent below univent fresh air intake

13. Remove plants growing against building and its foundation to prevent water intrusion through brickwork.
14. Clear plant growth and other materials/debris away from the proximity of univent air intakes.

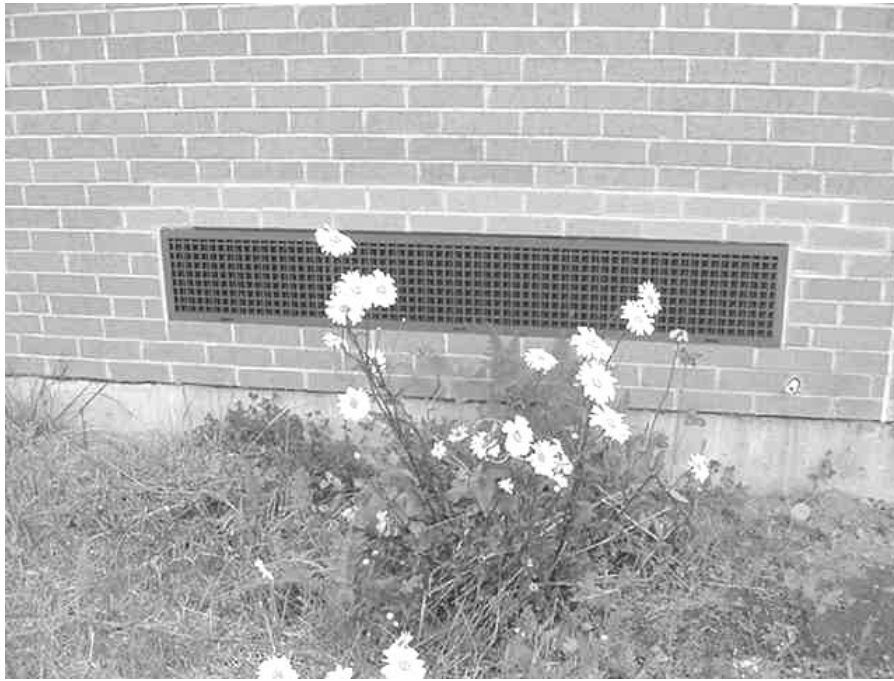
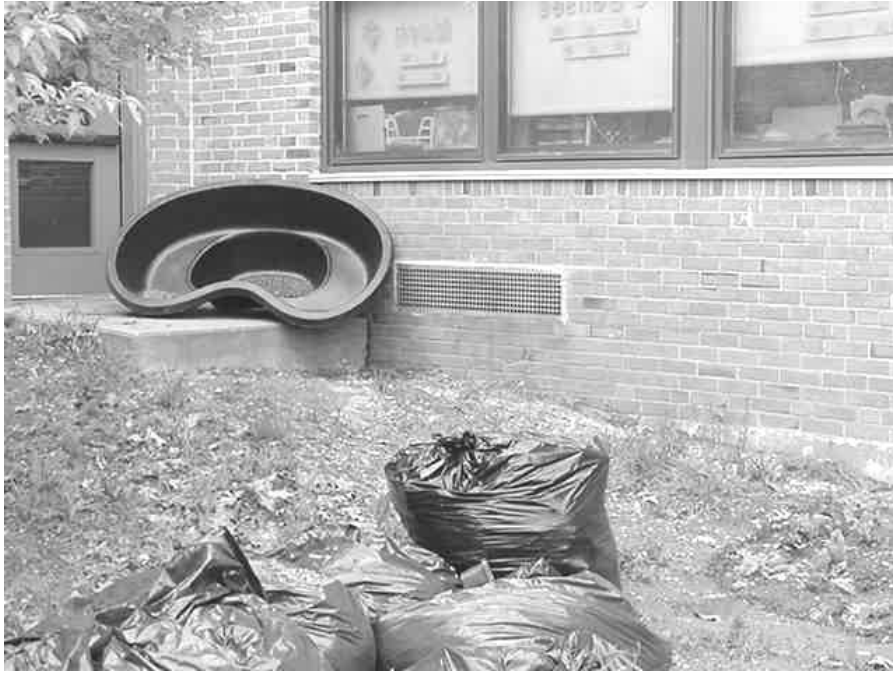
Picture 20

Plants near univent fresh air intake

Materials and garbage near univent fresh air intake

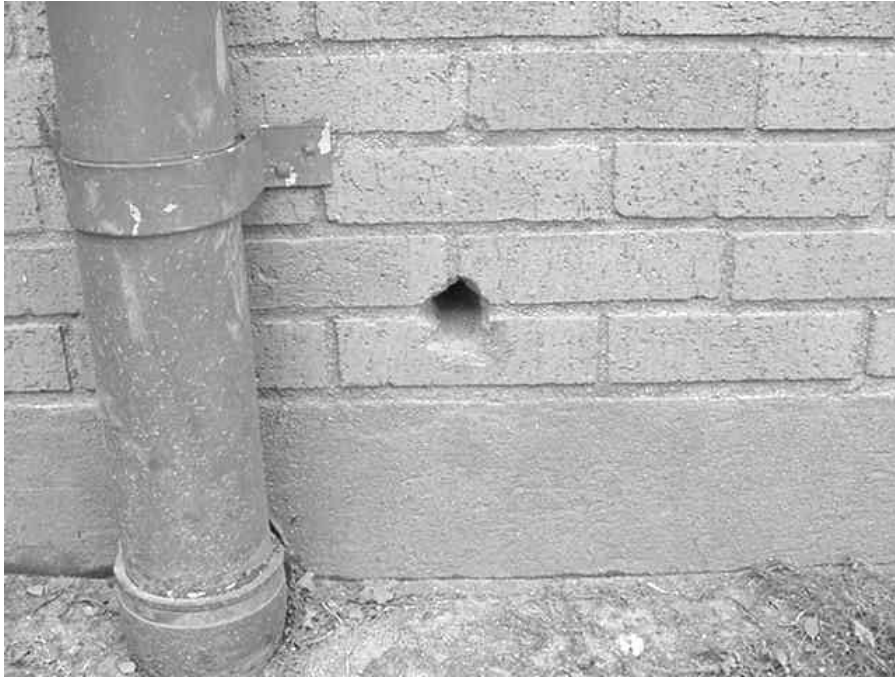
Picture 22

particularly under driving rain conditions. Excessive exposure of the exterior brickwork and foundation to water can result in structural damage.

Open utility hole

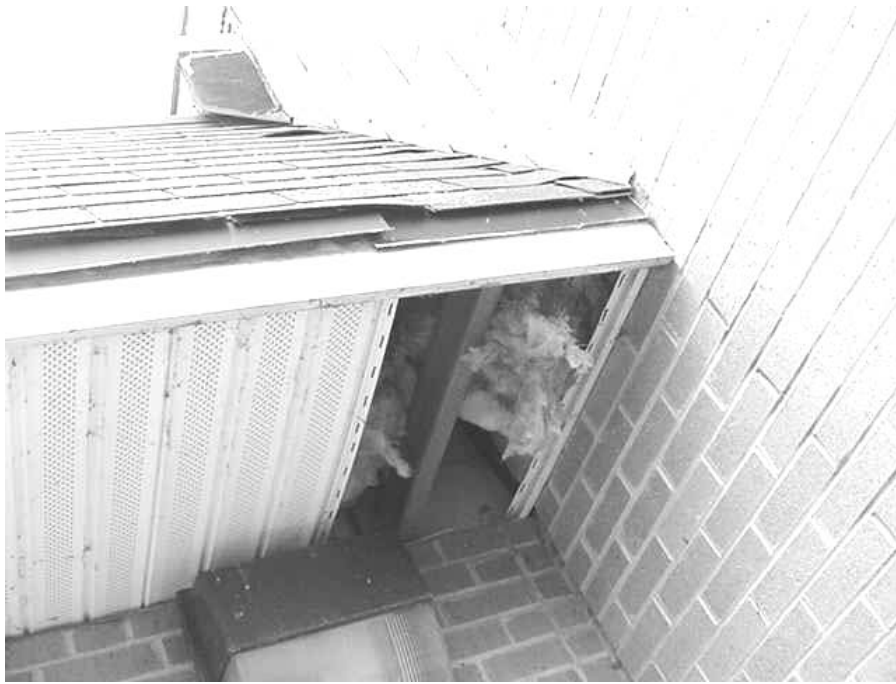
Picture 23

Soffit vents were observed to be missing from a roof at the rear of the building (Picture 23). The missing vents create an opening that has allowed birds to enter and roost in the roof, as evidenced by nesting materials observed through the vents and birds observed flying in and out of the missing vent area. Birds can be a source of disease, and bird wastes and feathers can contain mold, which can be irritating to the respiratory system.

Exposed fiberglass insulation was also observed hanging out from the missing soffit vent. If moistened, fiberglass insulation can wick and hold moisture against the building exterior. Over time, moisture held against a building can cause damage to the exterior wall. In addition the paper backing of insulation can provide a medium for mold growth, if wetted repeatedly.

Missing soffit vent with exposed fiberglass insulation

17. Use appropriate precautions (e.g., wearing protective equipment) when cleaning areas above soffit vents and when removing damaged insulation.
18. Examine damaged fiberglass insulation and replace if necessary.

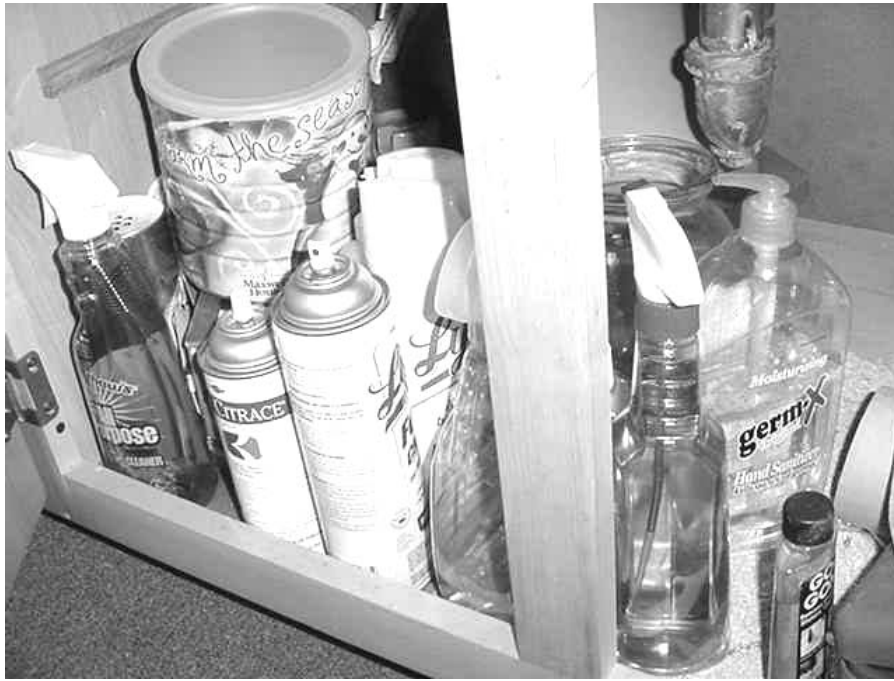
Picture 24

Cleaning products were found on countertops and in unlocked cabinets beneath sinks in some classrooms (Picture 24). Like dry erase materials, cleaning products contain VOCs and other chemicals that can be irritating to the eyes, nose and throat of sensitive individuals. In addition, plug-in air fresheners/deodorizers were in use in some classrooms (Picture 25). These products contain chemicals that can be irritating to the eyes, nose and throat of sensitive

Assortment of cleaners and disinfectants

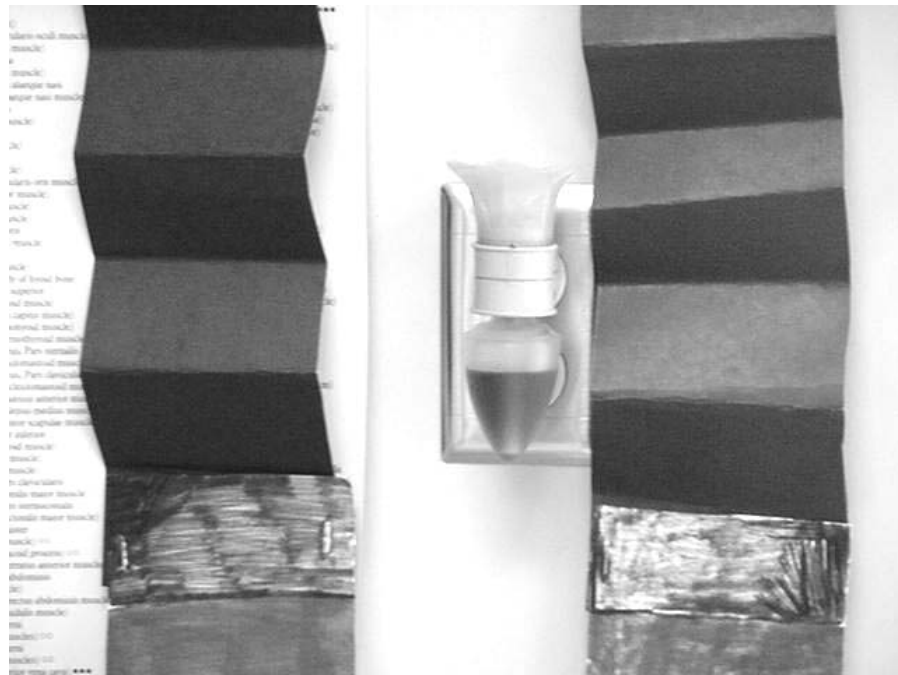
Picture 25

individuals. Furthermore, air fresheners do not remove materials causing odors, but rather mask odors that may be present in the area.

Plug-in air deodorizer

21. Refrain from using strongly scented materials (e.g., air fresheners) in classrooms.

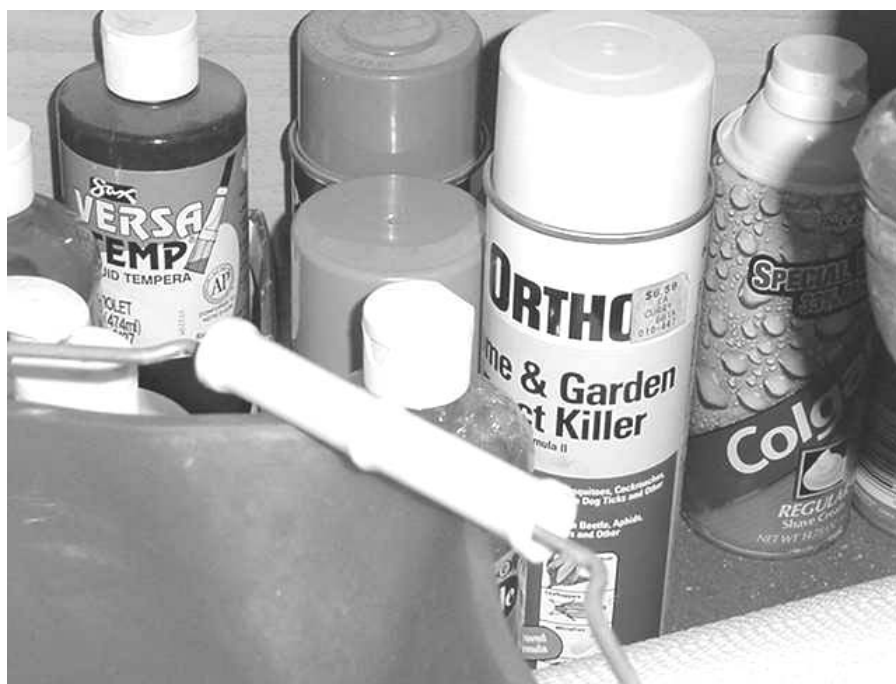
Picture 26

An aerosol canister of pyrethrin-based insecticide was observed in one classroom (Picture 26/Table 1). Pyrethrins have been associated with cross sensitivity in individuals who have ragweed allergy (EPA, 1992). Application of this product should be in accordance with the federal and state rules and regulations that govern pesticide use, including posting and notification requirements (333 CMR 13.10). Under no circumstances should untrained personnel apply this material on school properties. This product should not be applied prior to or during school hours. Under current Massachusetts law (effective November 1, 2001), the principles of integrated pest management (IPM) must be used to remove pests in state buildings (Mass Act, 2000). Pesticide use indoors can introduce chemicals into the indoor environment that can be sources of eye, nose and throat irritation.

Aerosol canister of insecticide

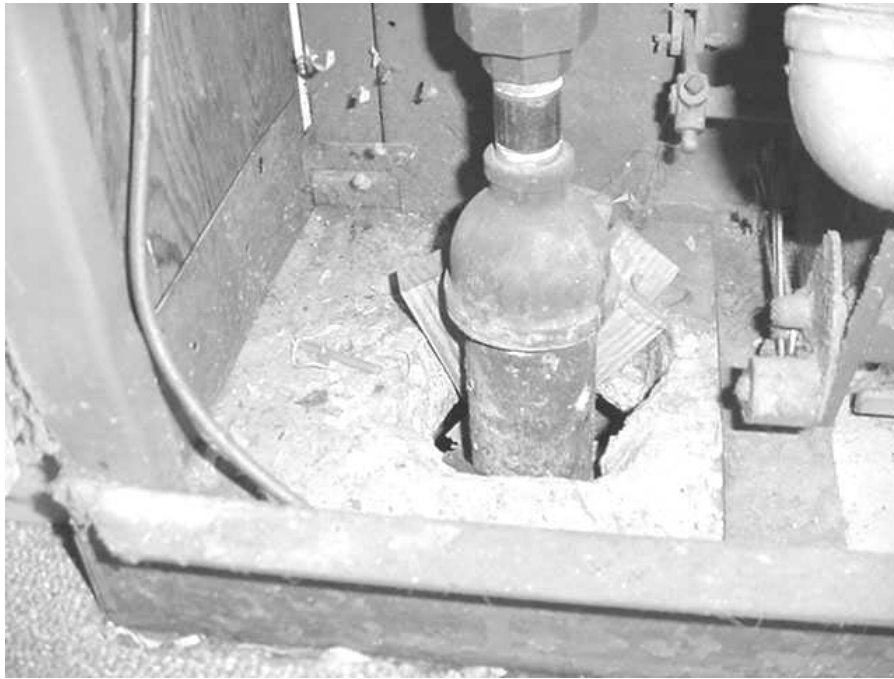
Picture 27

Other conditions that can affect indoor air quality were noted during the assessment. The interiors of several univents were examined. Spaces were observed around heating pipes that penetrate through the floor (Picture 27). Spaces of this nature can result in the draw of air and debris from the wall cavity or crawlspace, which can then be distributed to classrooms via the univent fan.

Breach around pipe, univent interior

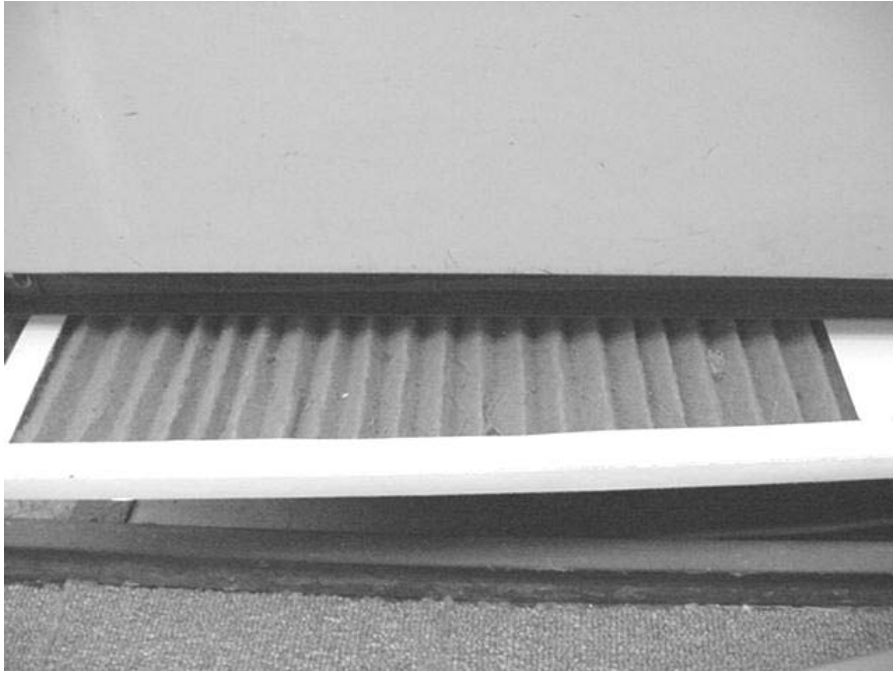
Picture 28

CEH staff inspected and found univent filters in a number of areas to be coated with dirt/dust and accumulated material (Picture 28). A debris-saturated filter can obstruct airflow and may serve as a reservoir of particulates that can be re-aerosolized and distributed to occupied areas via the ventilation system.

Occluded univent filter

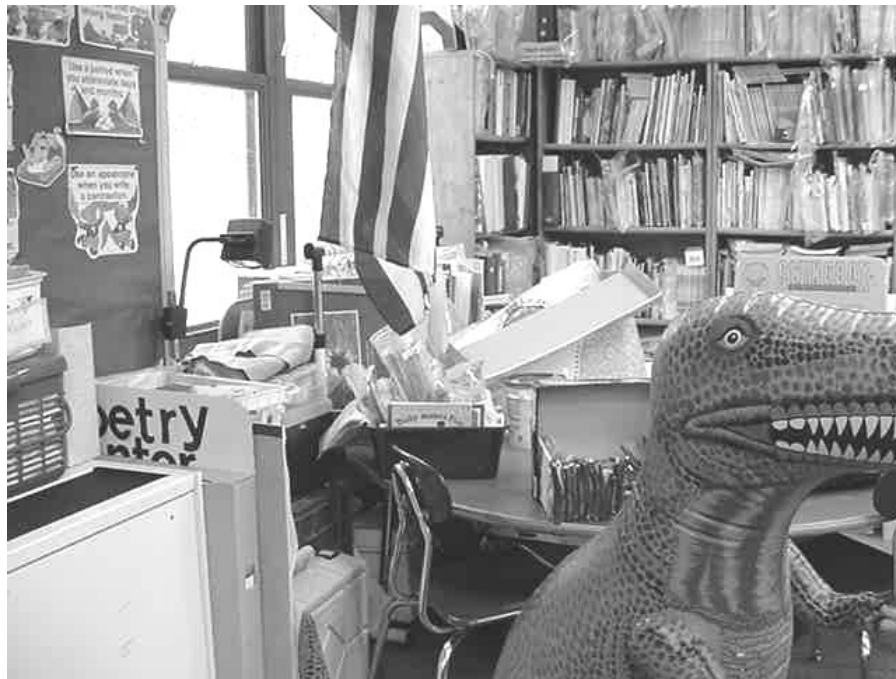
Picture 29

Also of note was the amount of materials stored inside classrooms (Picture 29). In classrooms throughout the school, items were observed on windowsills, tabletops, counters, univents, bookcases and desks. The stored materials in classrooms provide surfaces for dust to accumulate. Accumulation of these items (e.g., papers, folders, boxes) makes cleaning difficult for custodial staff. Dust can be irritating to eyes, nose and respiratory tract.

Placement and storage of materials

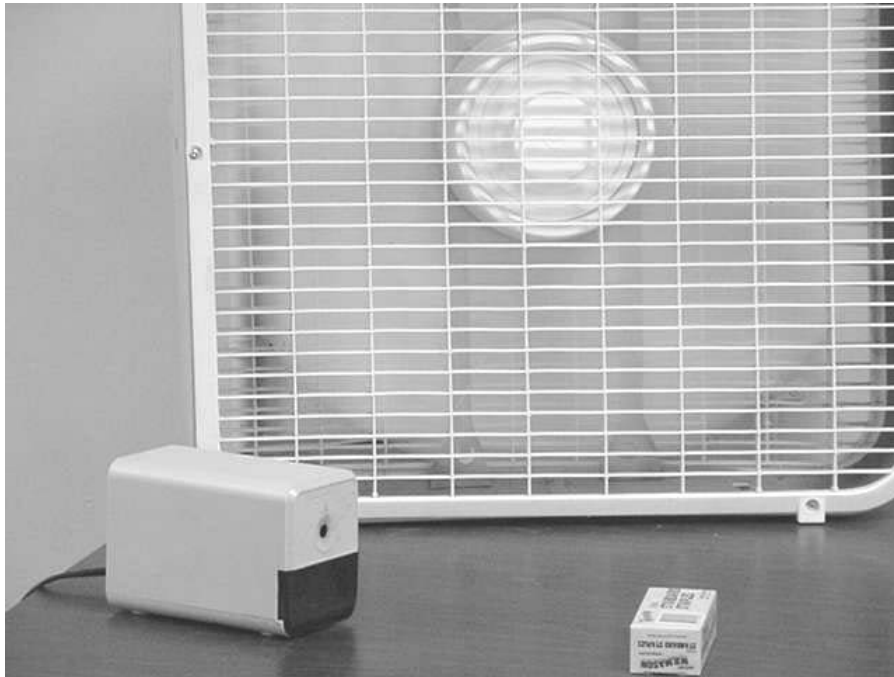
Picture 30

Accumulated chalk dust was seen in some classrooms. Chalk dust is a fine particulate that can easily become aerosolized. Once aerosolized, chalk dust can become irritating to eyes and the respiratory system. Similarly, pencil shavings were observed to be accumulating at the base of pencil sharpeners. In one classroom, a pencil sharpener was located in front of a fan (Picture 30). When operating, the fan can serve to aerosolize and distribute these materials.

Pencil sharpener in front of fan

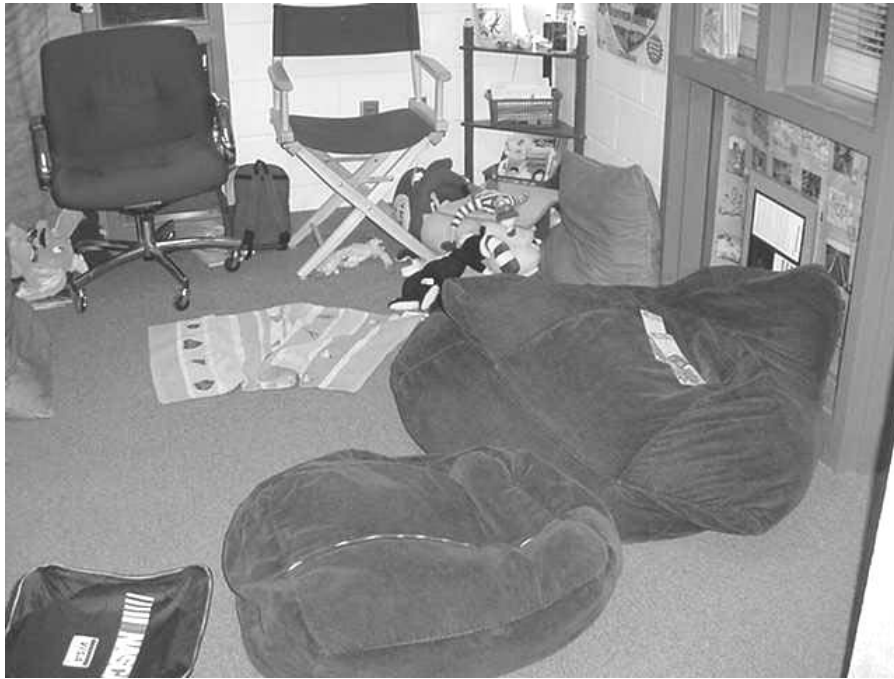
Picture 31

A number of classrooms contained upholstered furniture and pillows (Picture 31). Upholstered furniture is covered with fabric that encounters human skin. This type of contact can leave oils, perspiration, hair and skin cells. Dust mites feed upon human skin cells and excrete waste products that contain allergens. In addition, if relative humidity levels increase above 60 percent (e.g., during spring/summer), dust mites tend to proliferate (US EPA, 1992). In order to remove dust mites and other pollutants, frequent vacuuming of upholstered furniture is recommended (Berry, 1994). It is also recommended that if upholstered furniture were present in schools, it should be professionally cleaned on an annual basis or every six months if dusty conditions exist outdoors (IICRC, 2000).

Upholstered furniture and pillows

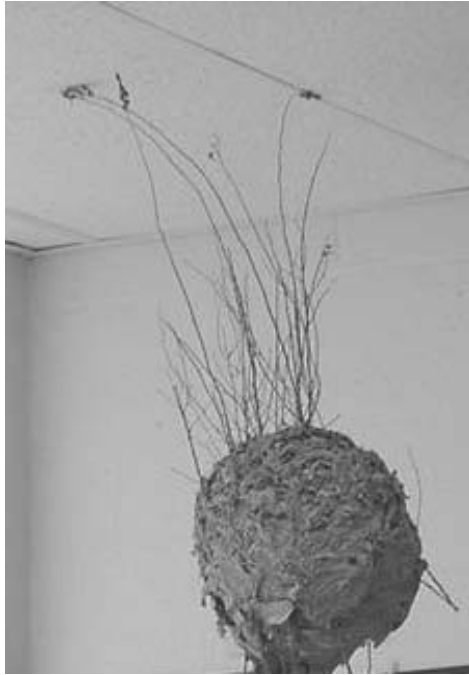
Picture 32

An inactive insect nest and other items were noted suspended from the ceiling system in one classroom (Picture 32). Nests can contain bacteria and may be a source of allergenic material. Nests should be placed in resealable bags to prevent aerosolization of allergenic material. In addition, items should not be suspended from ceiling tile systems. Movement of ceiling tiles may aerosolize dust above ceiling tiles. Moreover, heavy items may damage the ceiling tile frames.

Insect nest suspended from ceiling

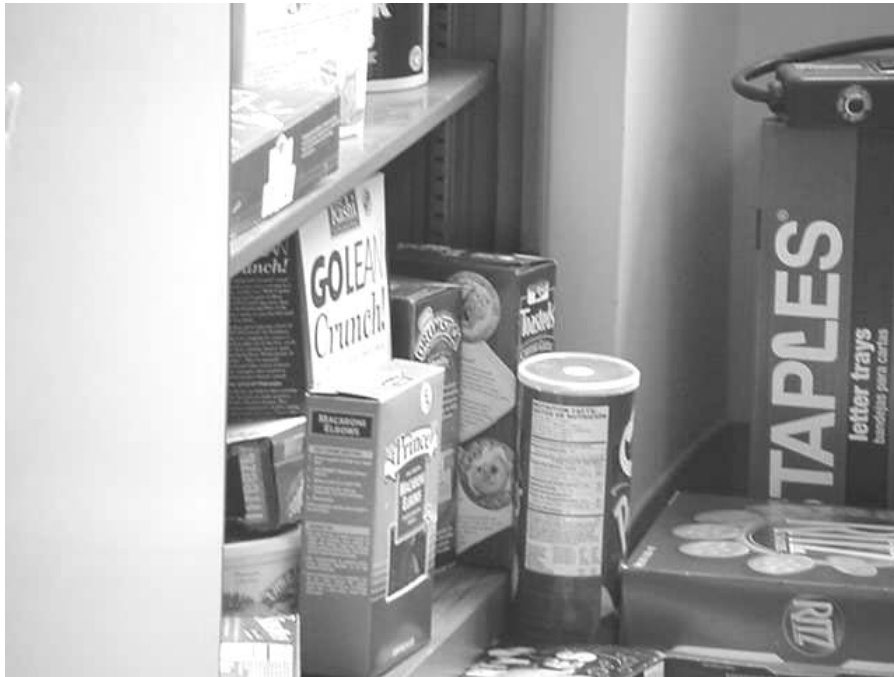
Picture 33

Lastly, food in open areas and the reuse of food containers were observed (Picture 33). Food is an attractant to pests and rodents. Proper food storage is an integral component in maintaining indoor air quality. Food should be properly stored and clearly labeled. Reuse of food containers is not recommended since food residue adhering to the surface may serve to attract pests.

Reuse of food containers
